TEST REPORT No. 1272-2003 Aeng

Report on acceptance test of a barrier construction

General Informations 1.1. Plant/Testing Object: "Nordic Crash Barriers" mobil Aluminium-Block-Barriers Width: 1250mm, Length: 1150mm, Height: 1185mm 12 Operator/Applicant: Nordic Staging ApS Odinsvei 26 4100 Ringsted Denmark 1.3. Manufacturer: see Point 1.2. 1.4. Construction, Static calculation: Ingenieurbüro Dr. Roland Ondra GmbH Richthofenstr. 5 86343 Königsbrunn

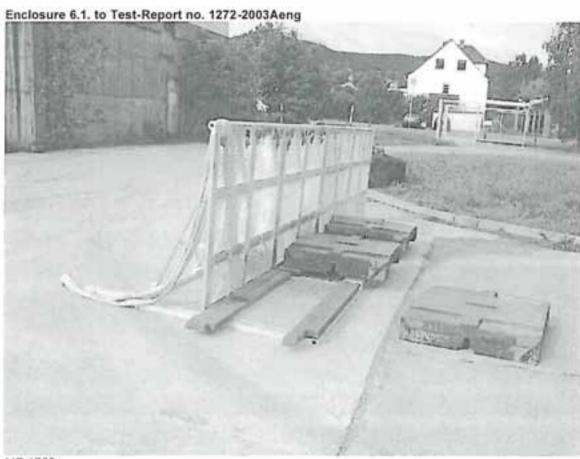
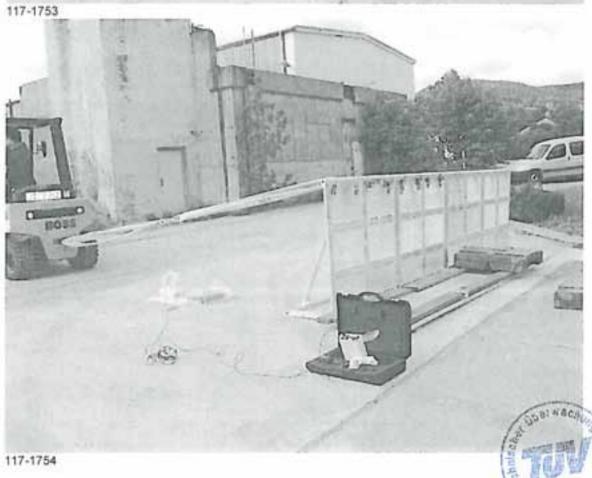
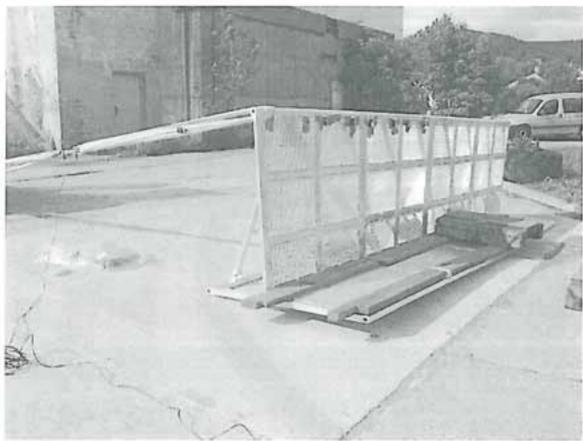
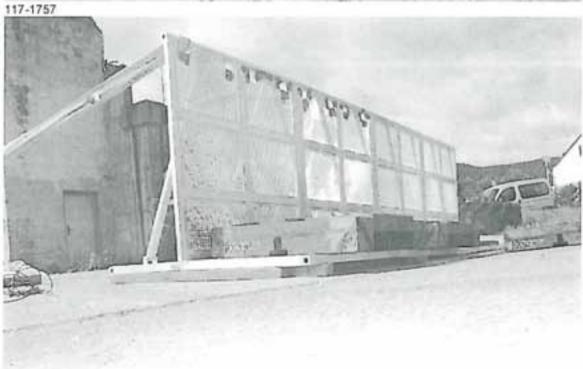
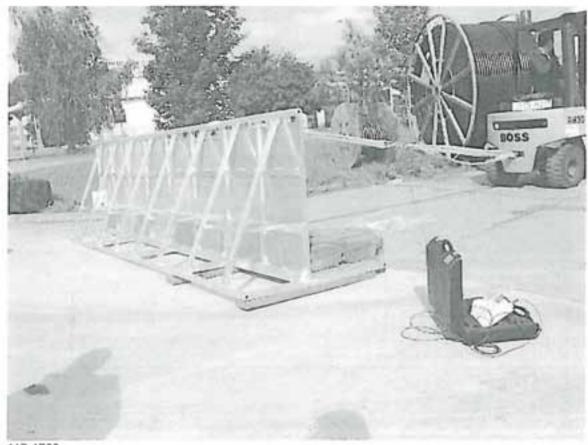
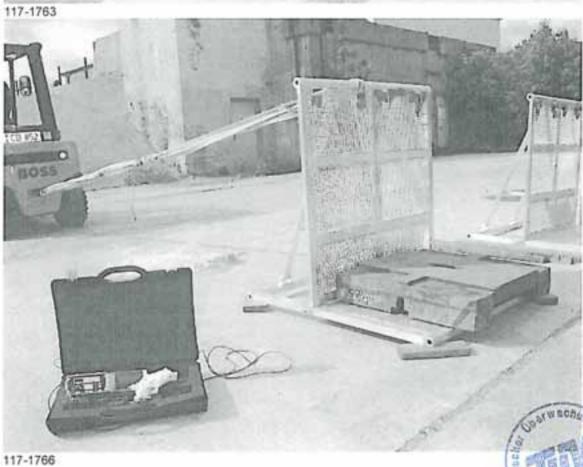
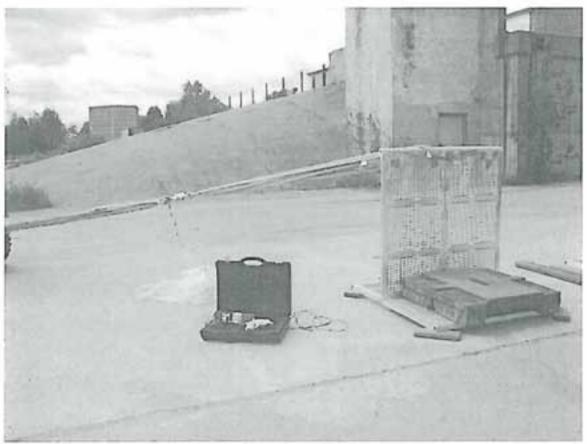
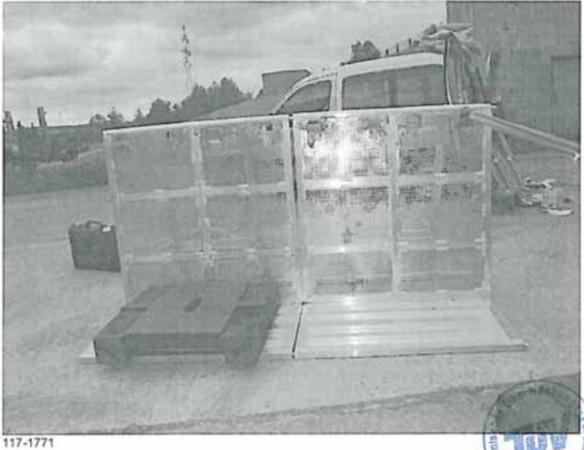
- 6. Enclosures:
- Pictures No.: 117-1753; 117-1754; 117-1757; 117-1759;

At tests no. 8 and 16, the barrier was 3,5- and 4-time overloaded according to the based DIN 4112 point 4.2.2.1. Test no. 9 shows, that at lightly vertical loaded barrier (2 persons), nearly the 3-time maximum horizontal load according to DIN 4112 is needed, to overturn the structure. Also the cases corner supported and slanting supported bearing (see Enclosure 6.3. Sheet of Measure; tests No. 11 to 14 and 17 to 21, pictures No. 117-1759, 117-1763 and 117-1766, 117-1767) under maximum load performed without significant reactions.

At test no. 22 a horizontal lengthwise load was applied onto the barriers. The construction, which is only screwed in the bottom frame between the elements, shows a vertical V-shape and app. 3cm wide gap between the top-bars of barriers (see pictures No. 117-1771). Further, a load test with 280 kg of the step (see point 3.1.) was performed without significant reactions. This test is not considered in the Sheet of measure.

After test series obviously heavy duty elements were subjected to an thorough visual check and to dye penetration tests. The load-bearing structure and welded seams carried the loads without suffering detectable damage, visible cracks or permanent deformations.

The gap between the barriers was caused by an improbable load for the structure in its planned application. Nevertheless it is recommended, make a tensile-fixed connection also between the top-bars of barrier elements, to certain avoid the risk of any injuries (see Requirement 4.3.) From static and constructive point of view there are no reservations against the planned use of the barrier construction.

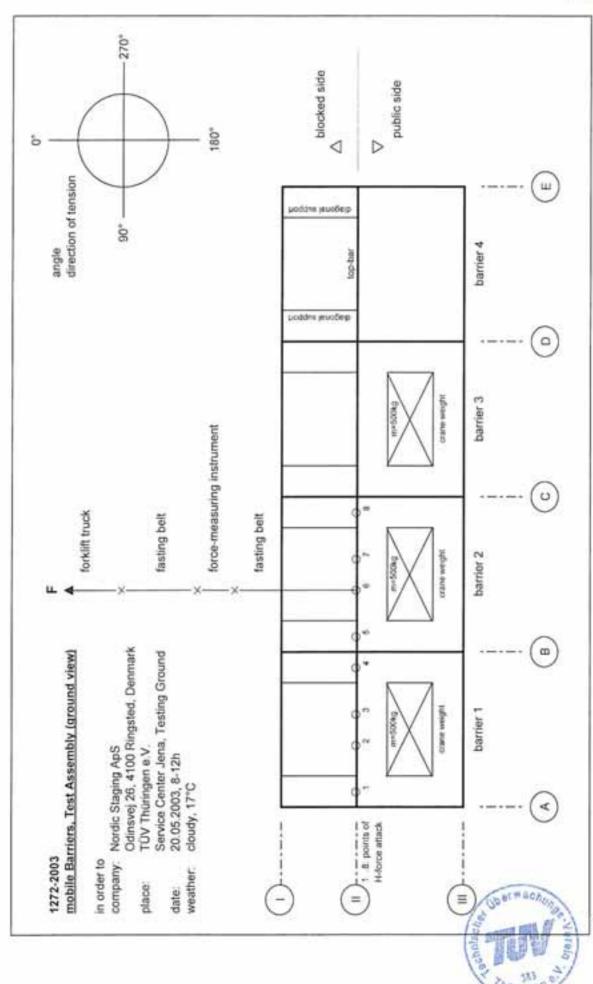
Enclosure 6.2. to Test Report No. 1272-2003Aeng

3.2.1. Test assembly (see Enclosure 6.2.):

The test series comprised 4 completely assembled barrier elements. If required, the segments were connected in row or tested as single elements. Putting test loads in form of crane weights on the upper surface of the barriers (500 kg), the maximum live load required in the standard DIN 4112, point 4.2.1.2, could be registered almost exactly for the respective surface. With a forklift truck and two fasting belts, the horizontal passenger load was given onto the top-bar. This force was controlled by a measuring instrument installed between the fastening belt and the truck. The two fasting belts balanced the difference in altitude between coupling of forklift truck and top-bar of barrier. Measured force can be accepted as horizontal-active. (see Enclosure 6.2., picture No. 117-1754).
